TEST REPORT NUMBER CFR2405291

FIRE RESISTANCE TEST IN ACCORDANCE WITH BS 476: PART 22: 1987

Sponsor:	Dixon International Group Ltd	Wood International Agency Limited
Address:	Brewery Road, Pampisford, Cambridgeshire, CB22 3HG	Wood House, 16 King Edward Road, Brentwood, Essex, CM14 4HL
Date of test:	29 th May 2024

Two latched single acting single leaf timber doorsets with an aperture for glazing, each tested opening towards the heating conditions of test with the left hand doorset tested as insulated and the right hand doorset tested as partially insulated.

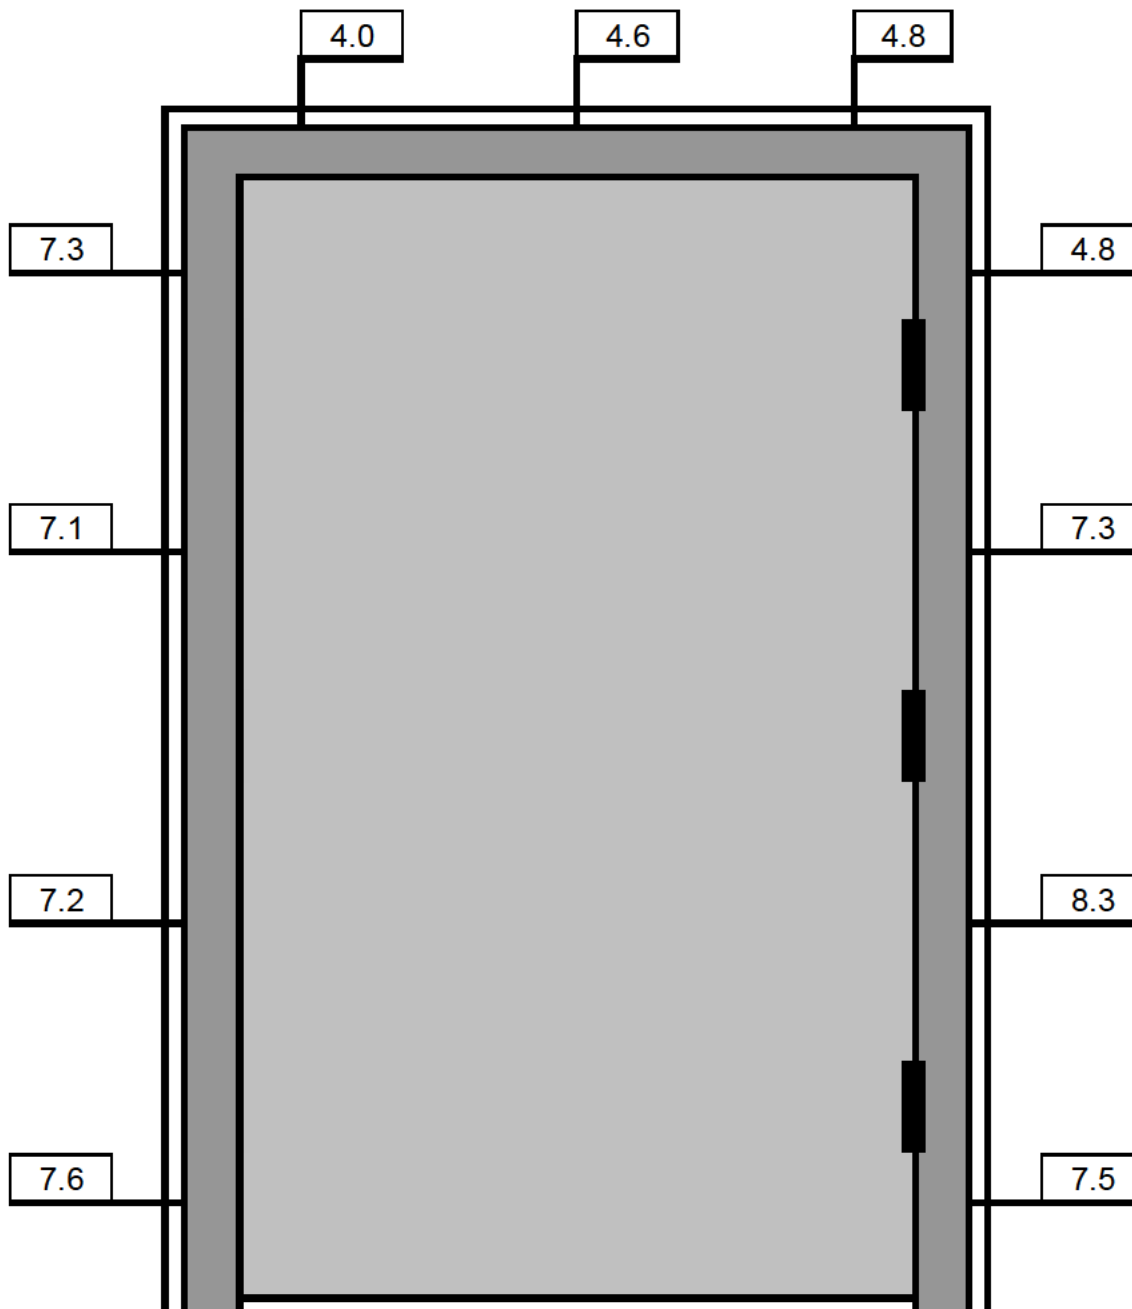
The gap between the specimen frame and the associated construction was measured prior to the start of the test.

The position at which the measurements were made and the recorded gap at those positions are shown in the following figure(s).

Left hand specimen viewed as measured from the exposed face.

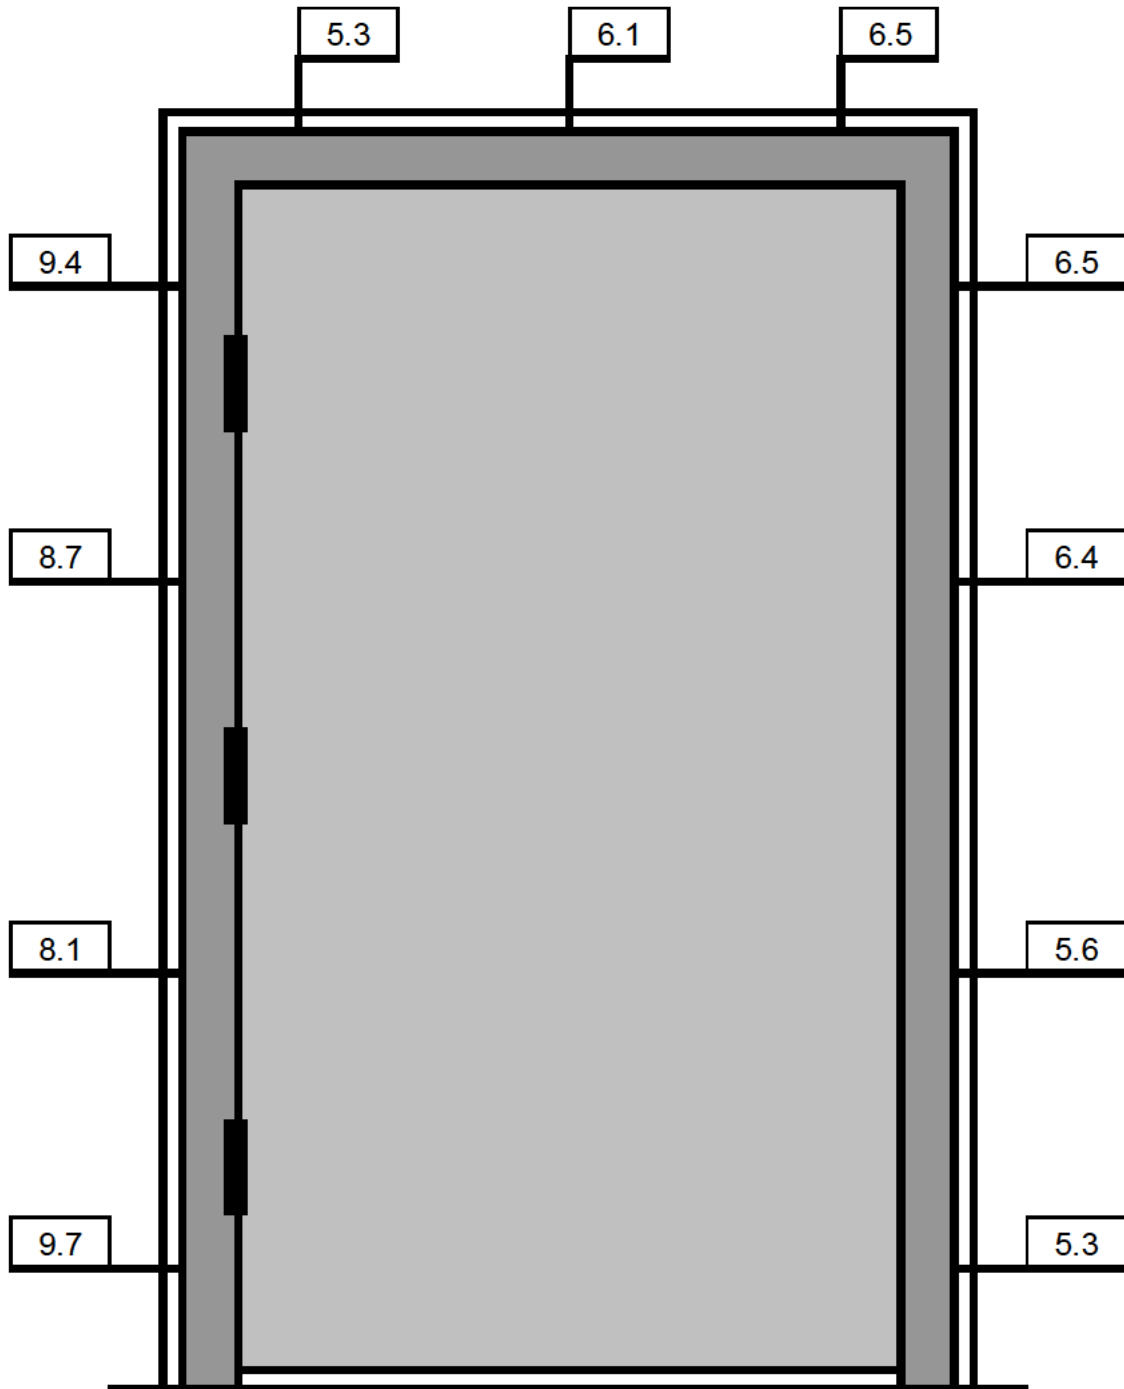
Right hand specimen viewed as measured from the exposed face.

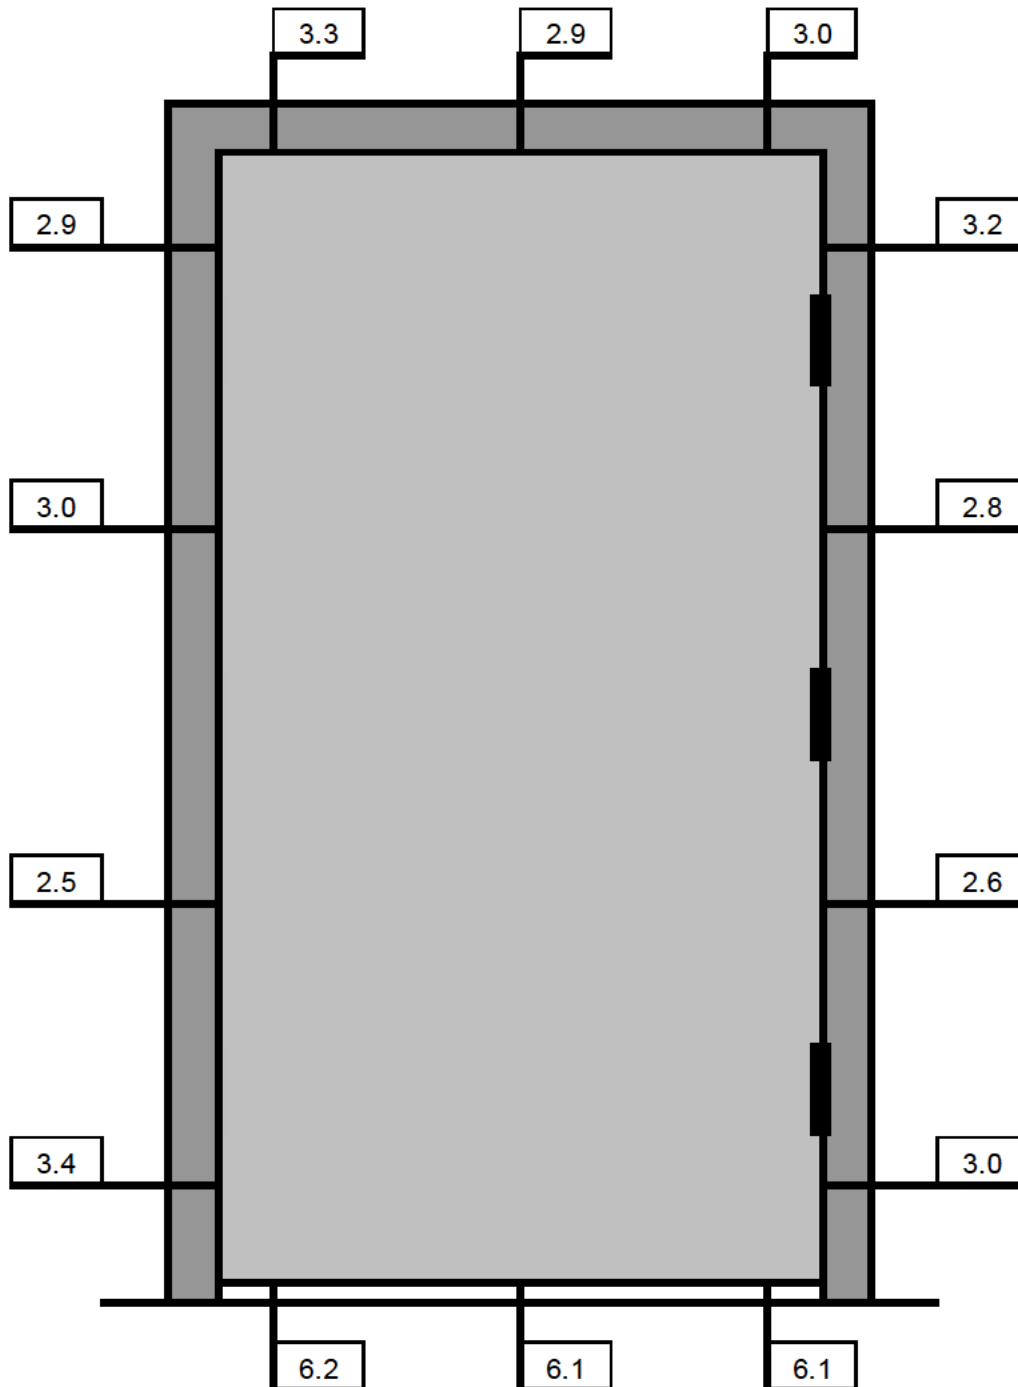
The gaps between the leaf edges and the frame and between the base of the leaf and the threshold were measured prior to the start of the test.

The position at which the measurements were made and the recorded gap at those positions are shown in the following figure(s).

Left hand specimen viewed as measured from the exposed face.

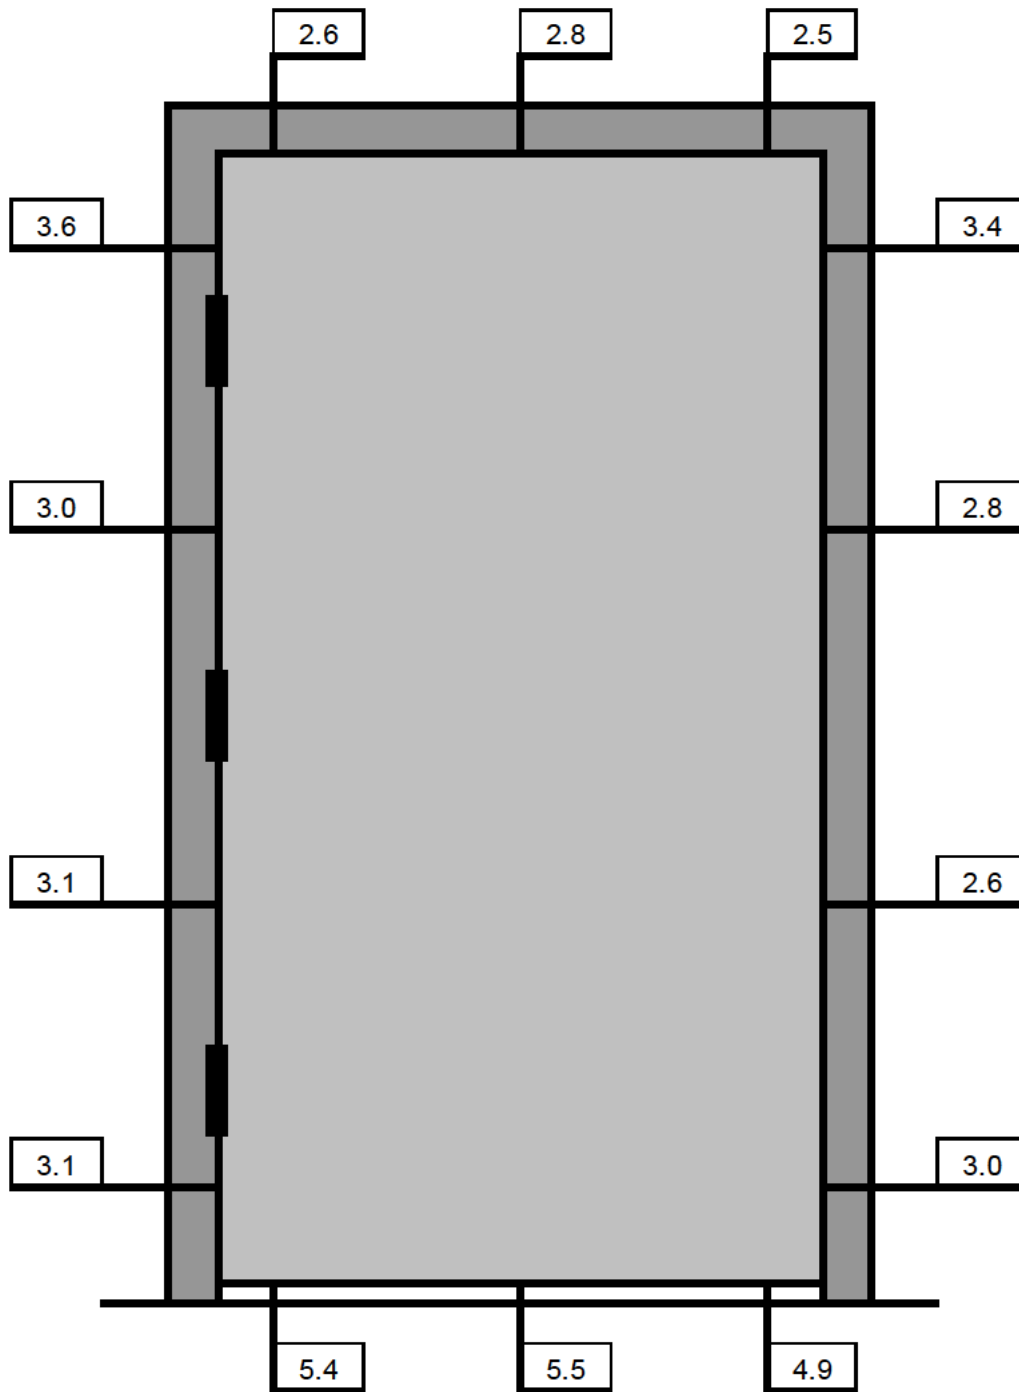
Right hand specimen viewed as measured from the exposed face.

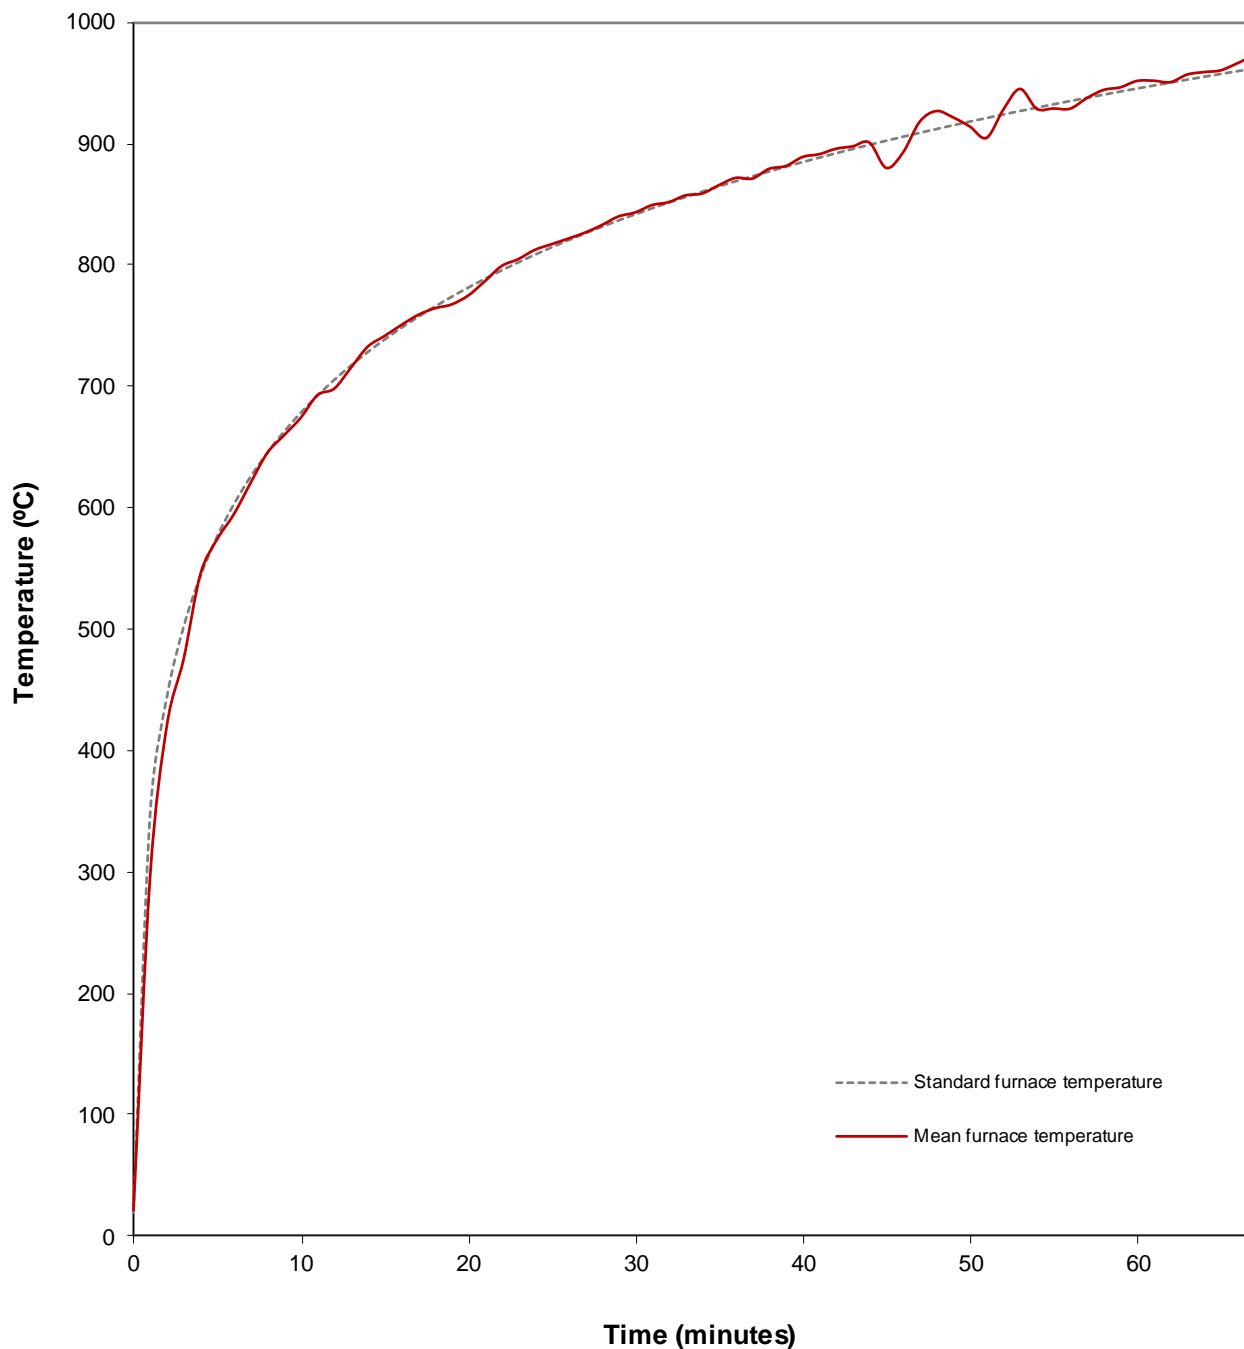
Furnace temperature was controlled so as to follow the standard temperature/time curve defined in the test standard and within the tolerances permitted. The furnace mean temperature was calculated from the output recorded using nine furnace thermocouples of the design specified in the test standard.

The following graph shows the standard and mean furnace temperature/time data.

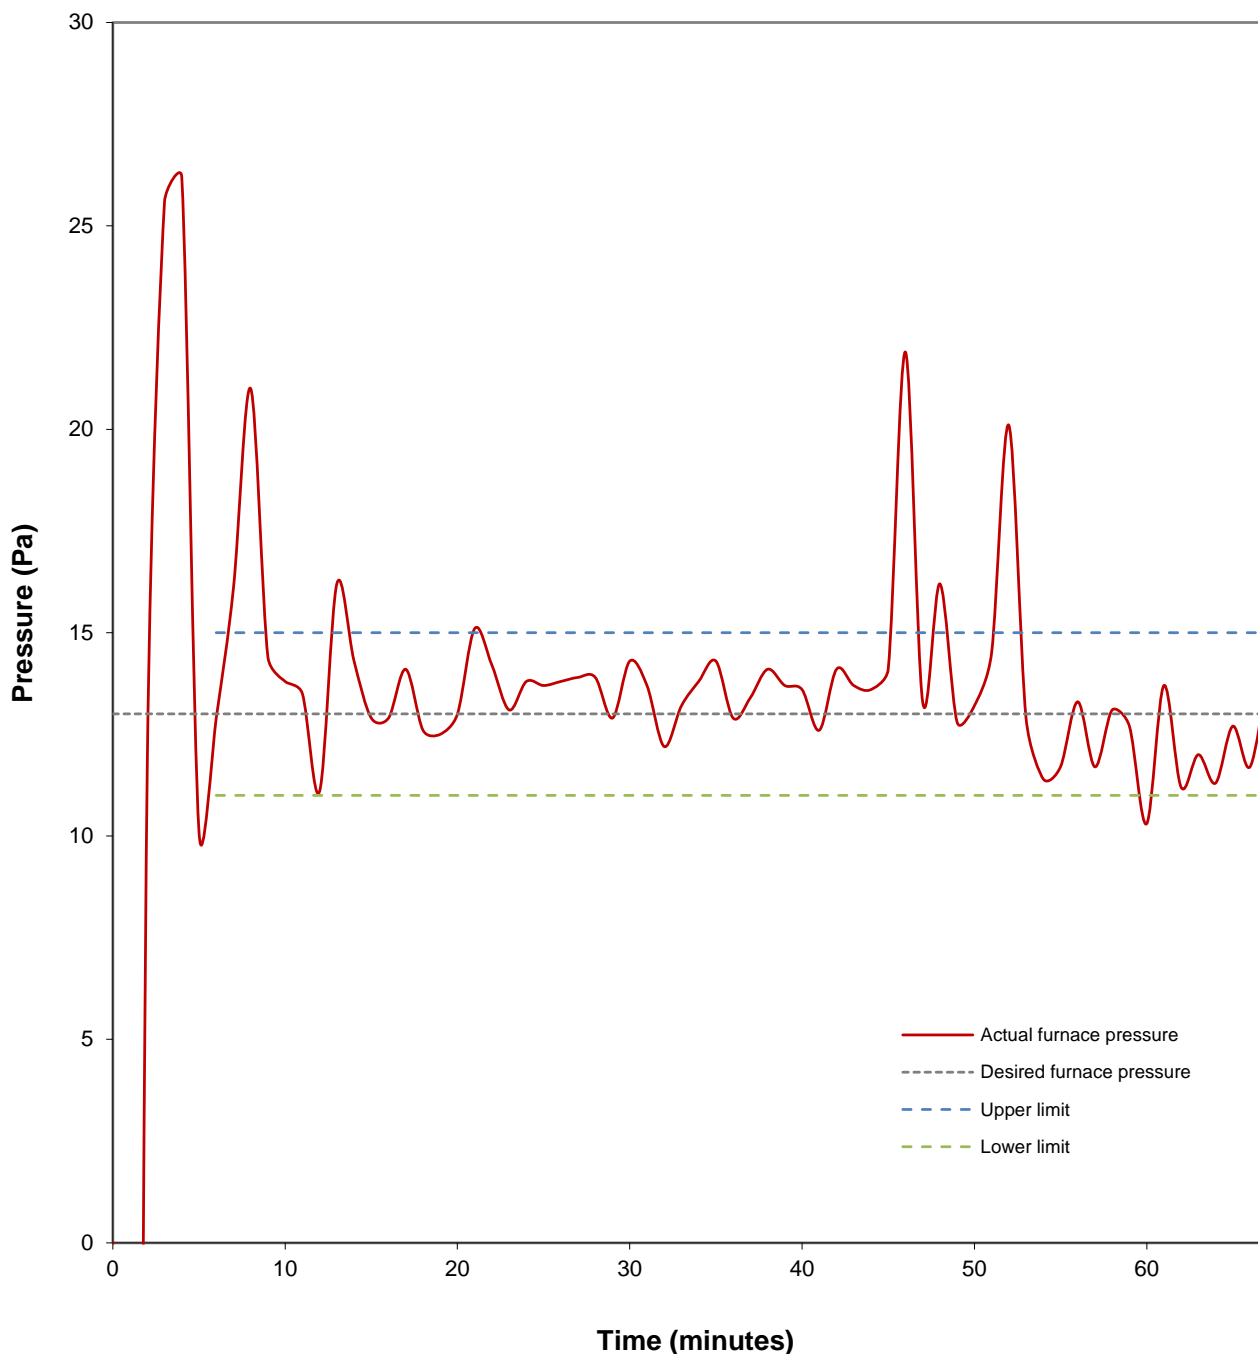
Furnace pressure was maintained for the duration of the test at a nominal + 13 Pa measured at the pressure sensing head. When a linear pressure gradient of 8.5 Pa/m is applied this equates to + 0 Pa at 1 m above the notional floor level. The furnace pressure was controlled within the tolerances permitted in the test standard, except for 9 instantaneous occasions which were transient events.

The following graph shows the actual and desired furnace pressure/time data.

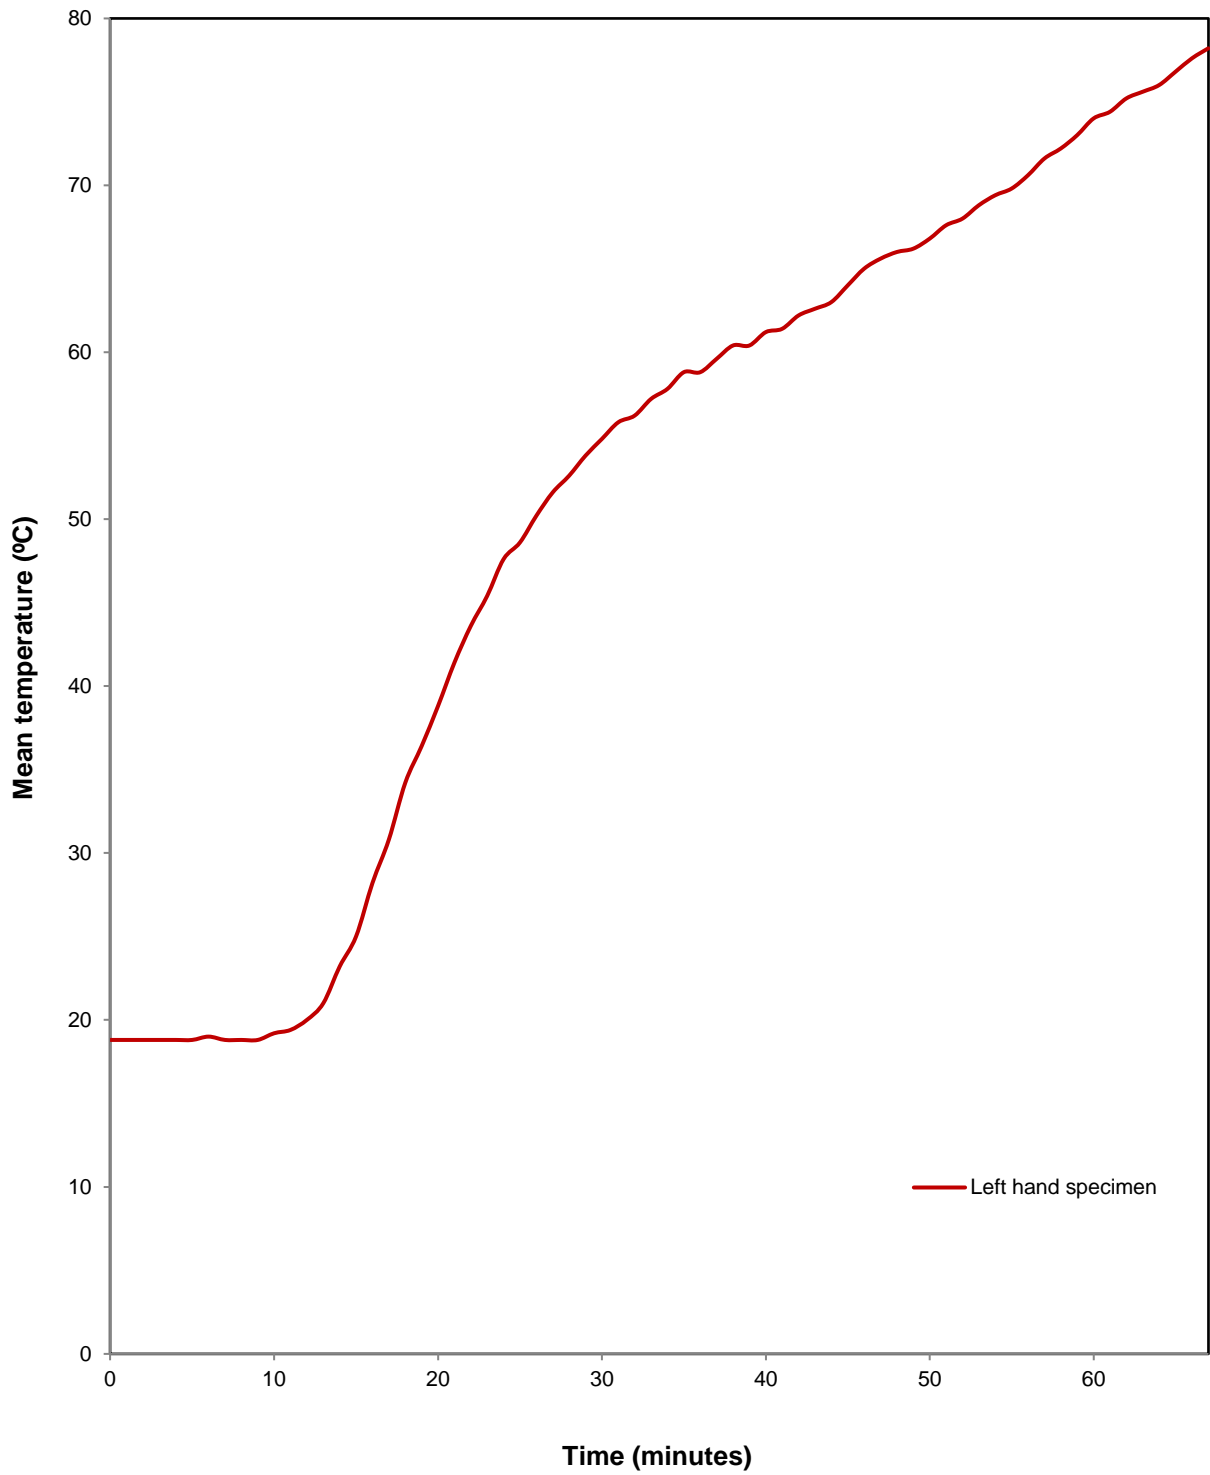
Left hand specimen

Surface temperature measuring thermocouples of the design specified in the test standard were affixed to the unexposed face of the specimen(s) to monitor the temperature rise as follows:

Leaf	Channels 16 to 20	(mean & maximum)
Frame	Channels 21 to 23	(maximum only)
Glazing	Channels 32 to 33	(information only)

The following time/temperature graph shows the mean temperature.

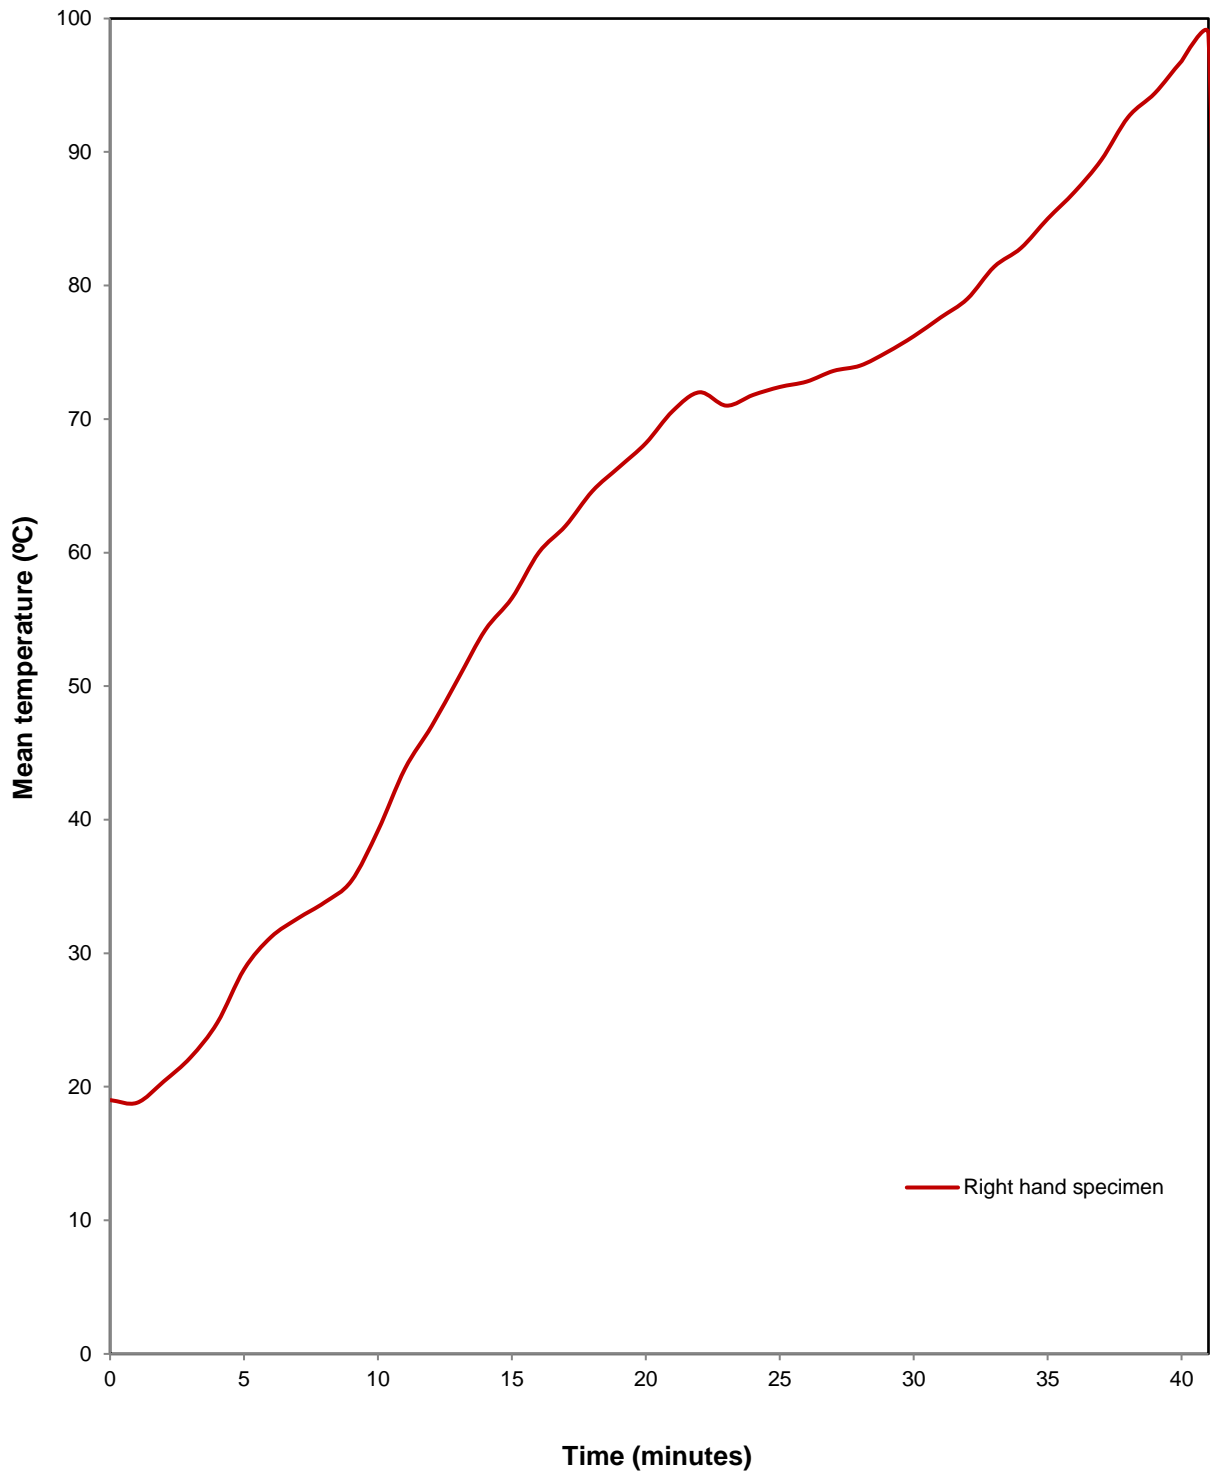
Right hand specimen

Leaf	Channels 24 to 28	(mean & maximum)
Frame	Channels 29 to 31	(maximum only)

40:00	U	INSULATION FAILURE due to thermocouple 26 exceeding the maximum temperature rise criteria.
40:29	U	Flash flaming occurs at the closing stile/head corner.

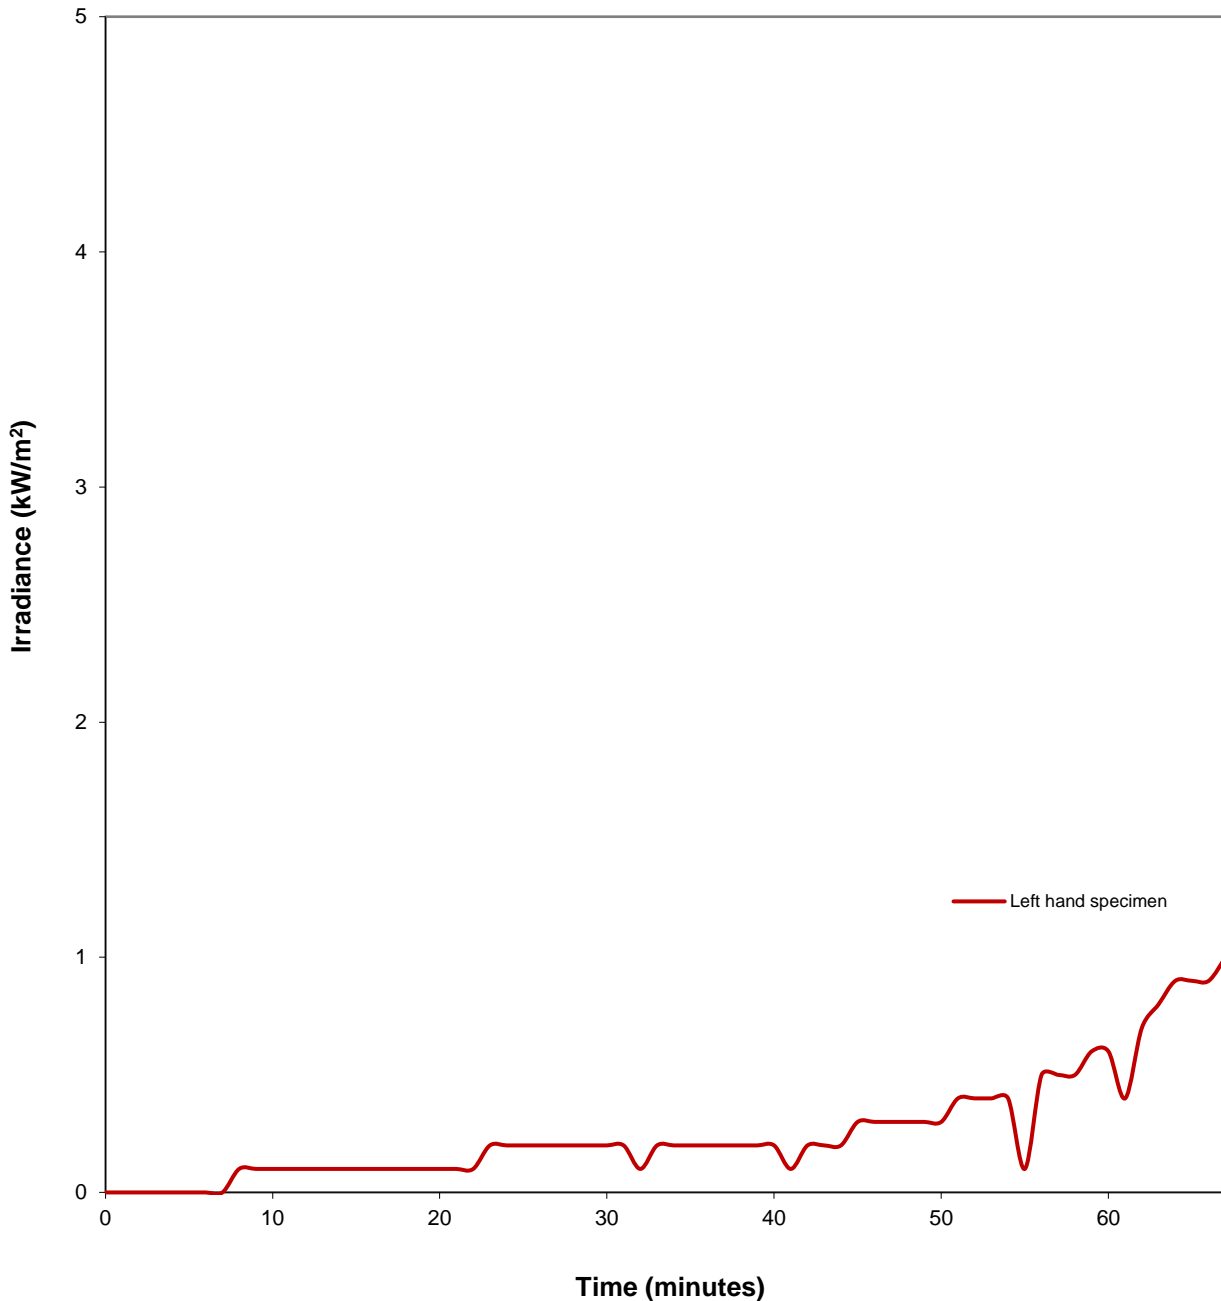
Left hand specimen

Irradiance from the unexposed face of each specimen was monitored during the test. A 180° field of view water cooled heat flux meter was positioned with its target 1 m from and parallel to the unexposed face of the specimen at the geometric centre. The following graphs shows the recorded irradiance/time data.

It should be noted that the recorded value of heat flux drops when the field of view is physically interrupted during the measurement of deflection.

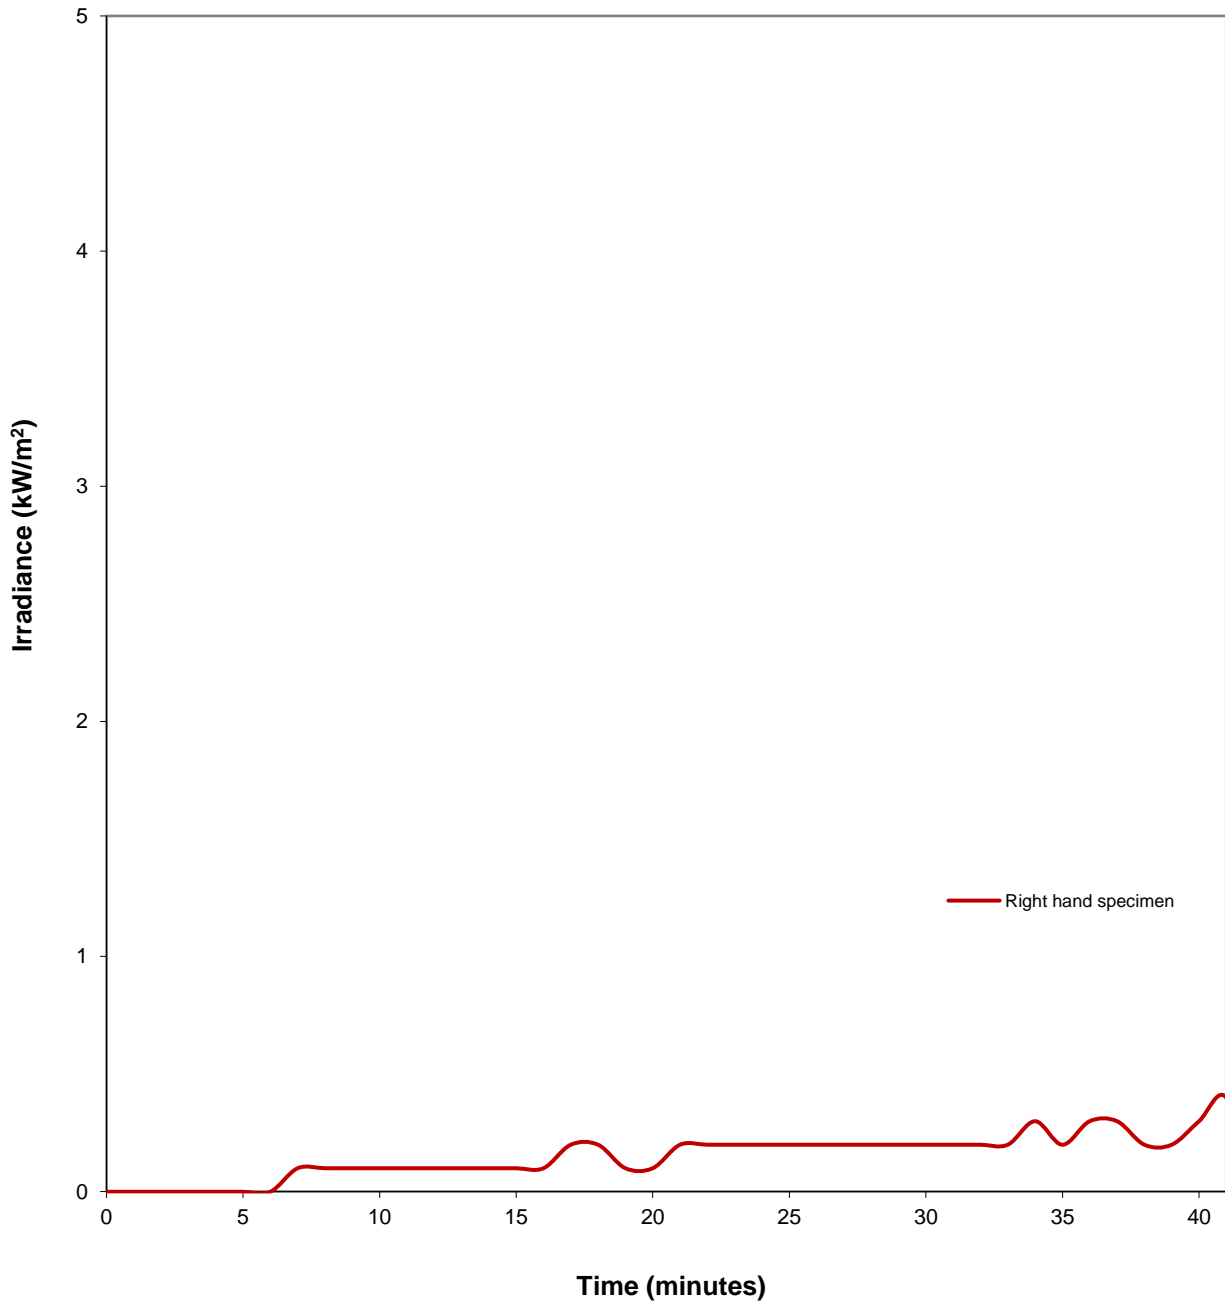
Right hand specimen

It should be noted that the recorded value of heat flux drops when the field of view is physically interrupted during the measurement of deflection.

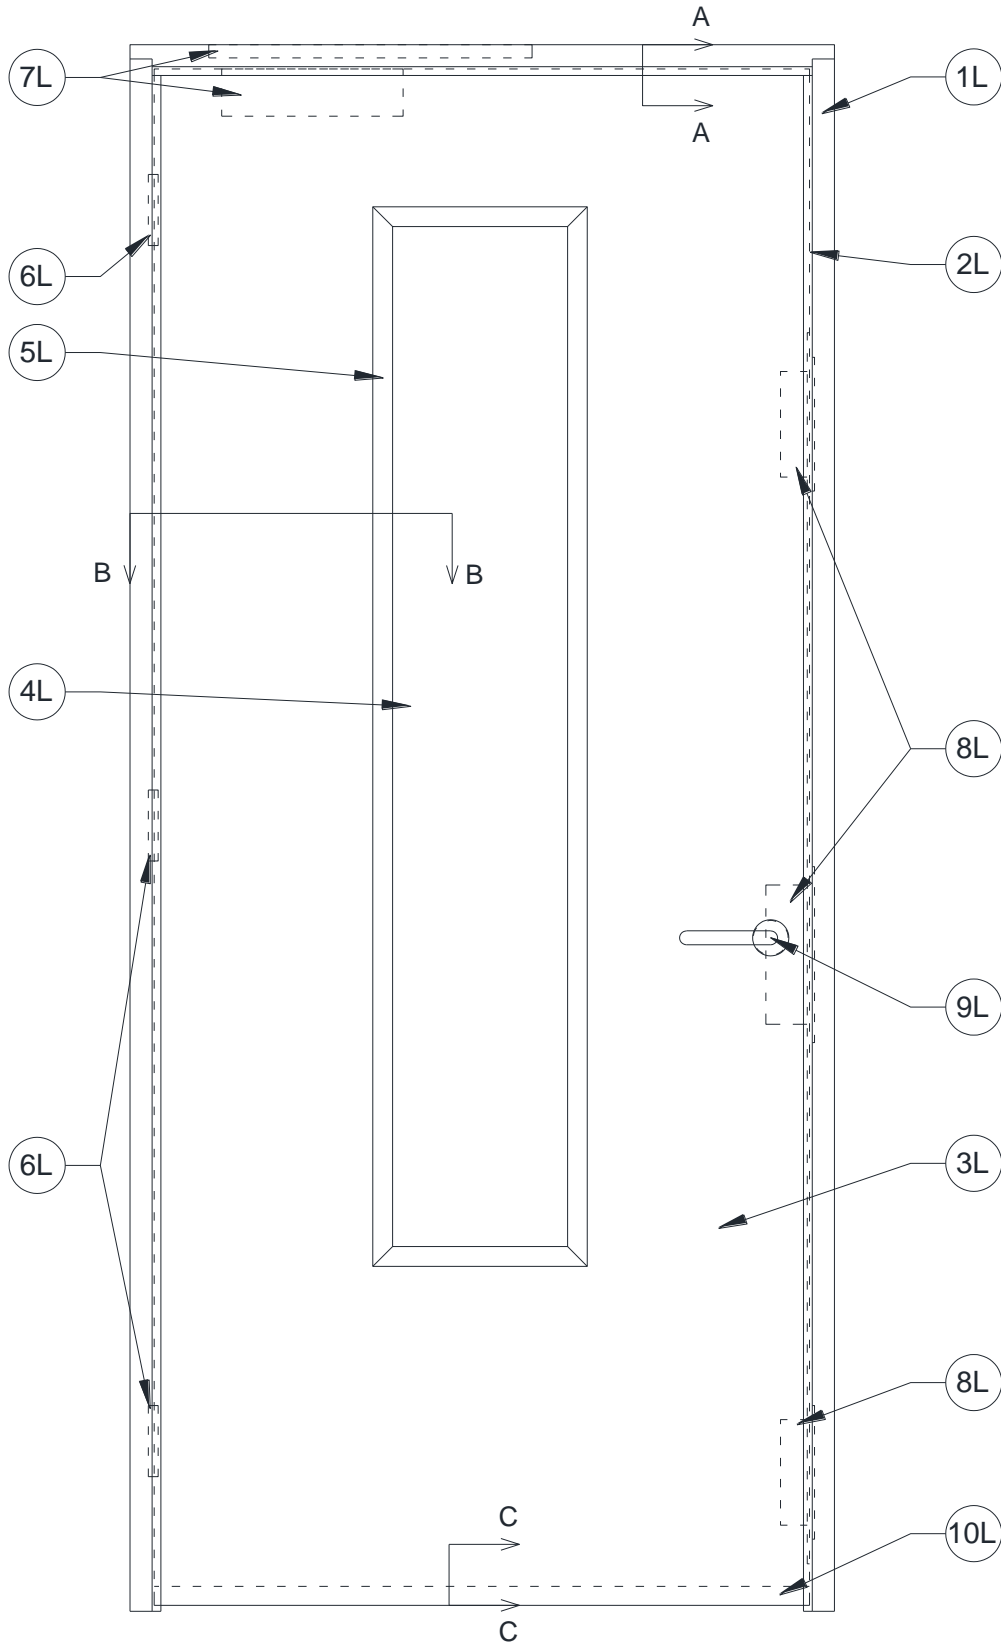
Appendix 1 Figure 1 – Left hand doorset elevation (unexposed face view) incl. hidden detail

Item	Component	Information
1L	<p>Frame Manufacturer: Reference: Description: Fixing to associated construction: Density (kg/m³) Overall size (h x w x d): Cross section size (w x d):</p>	<p>By Deziign Carpentry** Framebreak EU 550 from Wood International Agency Limited - Standard Frame with Plant on Stop** A 3-sided finger jointed laminated frame with 11h rebated joints and planted stops. Corner joints affixed using Ø4.7 x 79 countersunk steel screws, 1No. horizontally through each jamb into the head set at mid depth and 28 below the head, and 2No. vertically through head to each jamb at 62 centres. Joints adhered using Gorilla Wood Glue PVAc D3 adhesive**. Ø5 x 90 countersunk steel screws per jamb set 90 to 205 above the base and at 460 centres. 470 to 651** 2227 x 1002 x 96 32 x 96</p>
2L	<p>Stops Manufacturer: Reference: Description: Density (kg/ m³): Overall size (w x d):</p>	<p>By Deziign Carpentry** Framebreak EU 550 from Wood International Agency Limited** Finger jointed laminated stops affixed using 16#swg x 32# pneumatically fired steel pins set 50 to 70 above the base of the frame and at 145 to 200 centres. 470 to 651** 13 x 33</p>

3L	<p>Leaf Manufacturer: Reference: Description: Overall size (h x w x t): Weight (kg): Sub-components: Core: Manufacturer: Reference: Description: Density (kg/m³): Overall size (t): Lippings: Manufacturer: Reference:</p>	<p>By Deziign Carpentry** WIAD-MMN54-ITT-344-M1** A particleboard core with lippings and an aperture for glazing. 2184 x 932 x 54 68.1 including ironmongery Wood International Agency Limited** Marksman 54** A particleboard core. 529** 54 Wood International Agency Limited** Edgeman EV – Engineered Hardwood Lipping**</p>

6L	Hinges Manufacturer: Reference: Description: Overall size: Blade size (h x w x t): Knuckle size (Ø): Fixings to frame: Fixings to leaf :	Arrone AR8182-SSS** 3No. stainless steel butt hinges set 150, 1025 and 1900 from top of leaf to top of blade. 101 x 30 x 3 14 4No. Ø4.6 x 30 countersunk stainless steel screws. 4No. Ø4.6 x 30 countersunk stainless steel screws.
7L	Closer Manufacturer: Reference: Description: Overall size: Body (h x w x d): Case (h x w x d x t): Track (h x w x d): Fixings to leaf: Fixings to frame:	Rutland TS11205 An overhead closer with an alloy body, stainless steel track and steel case. 60 x 212 x 40 67 x 258 x 43 x 1.2 19 x 460 x 29 3No. Ø4.8 x 67 countersunk steel screws. 4No. Ø4.8 x 15 countersunk steel screws.

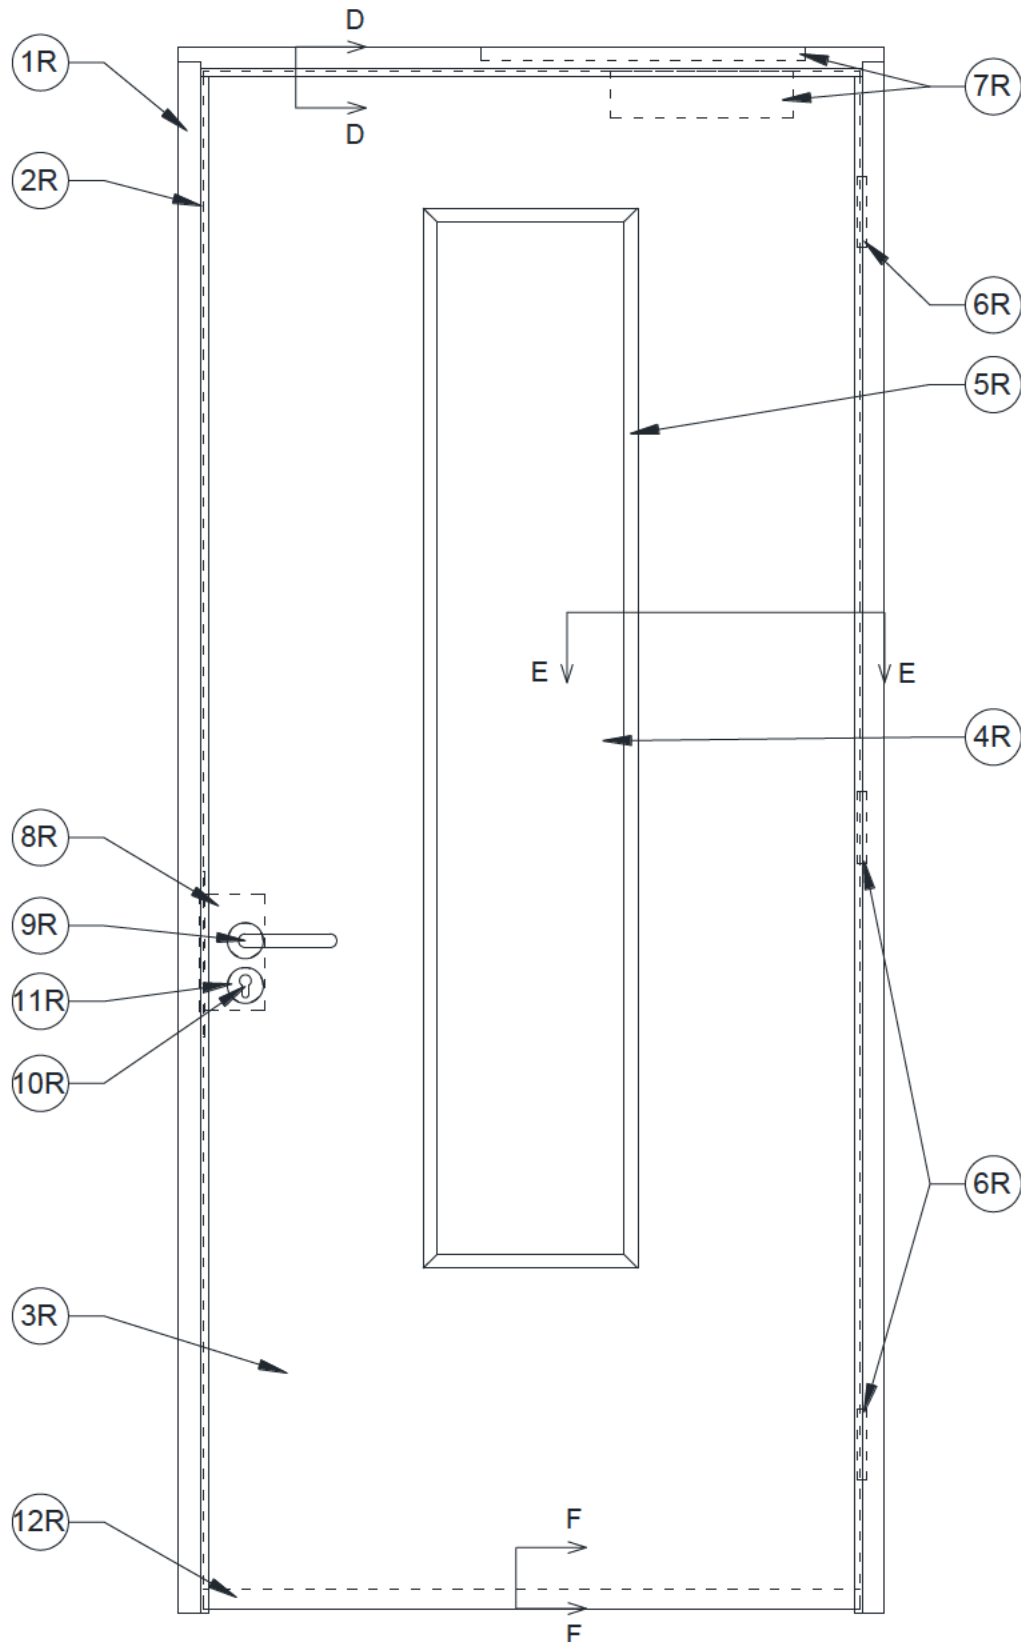
Appendix 1 Figure 5 – Right hand doorset elevation (unexposed face view) incl. hidden detail

Item	Component	Information
1R	<p>Frame Manufacturer: Reference: Description: Fixing to associated construction: Density (kg/m³) Overall size (h x w x d): Cross section size (w x d):</p>	<p>By Dezign Carpentry** Framebreak JA 380 from Wood International Agency Limited - Standard Frame with Plant on Stop** A 3-sided finger jointed laminated frame with 10h rebated joints and planted stops. Corner joints affixed using Ø4.8 x 79 countersunk steel screws, 1No. horizontally through each jamb into the head set at mid depth and 30 below the head, and 2No. vertically through head to each jamb at 58 centres. Joints adhered using Gorilla Wood Glue PVAc D3 adhesive**.</p> <p>Ø5 x 90 steel countersunk screws per jamb set 200 to 210 above the base at 460 centres.</p> <p>378 to 400** 2223 x 1002 x 96 31 x 96</p>
2R	<p>Stops Manufacturer: Reference: Description: Density (kg/ m³): Overall size (w x d):</p>	<p>By Dezign Carpentry** Framebreak JA 380 from Wood International Agency Limited** Finger jointed laminated stops affixed using 16#swg x 32# pneumatically fired steek pins set 50 to 70 above the base of the frame and at 145 to 200 centres.</p> <p>378 to 400** 12 x 33</p>

3R	<p>Leaf Manufacturer: Reference: Description: Overall size (h x w x t): Weight (kg): Sub-components: Core: Manufacturer: Reference: Description: Density (kg/m³): Overall size (t): Lippings: Manufacturer: Reference: Description:</p>	<p>By Dezign Carpentry** WIAD-MMN44-ITT-344-TL1** A particleboard core leaf with lippings and glazing aperture. 2183 x 933 x 44 56.8 including hardware</p> <p>Wood International Agency Limited** Marksman 44** A particleboard core. 515** 44</p> <p>By Dezign Carpentry** Std Square Lipping** Sapele** lipping adhered to all edges of the core using Wurth Rapid MCPU adhesive**.</p>

7R	Closer Manufacturer: Reference: Description: Overall size: Body (h x w x d): Case (h x w x d x t): Track (h x w x d): Fixings to leaf: Fixings to frame:	Rutland TS11205 An overhead closer with an alloy body, stainless steel track and steel case. 60 x 212 x 40 67 x 258 x 43 x 1.2 19 x 460 x 29 3No. Ø4.8 x 67 countersunk steel screws. 4No. Ø4.8 x 15 countersunk steel screws.

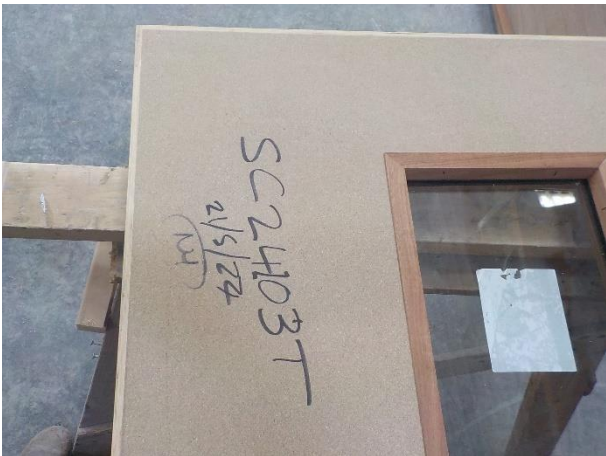
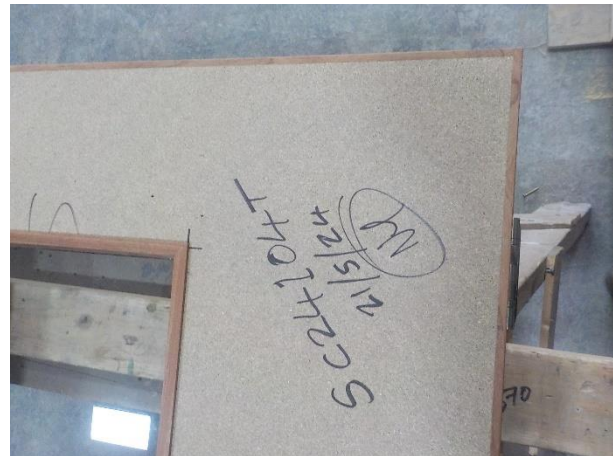
Photo 2.1.21 Left hand specimen

Photo 2.1.22 Right hand specimen

Appendix 2, photos 2.1.21 and 2.1.22 show corresponding identification.

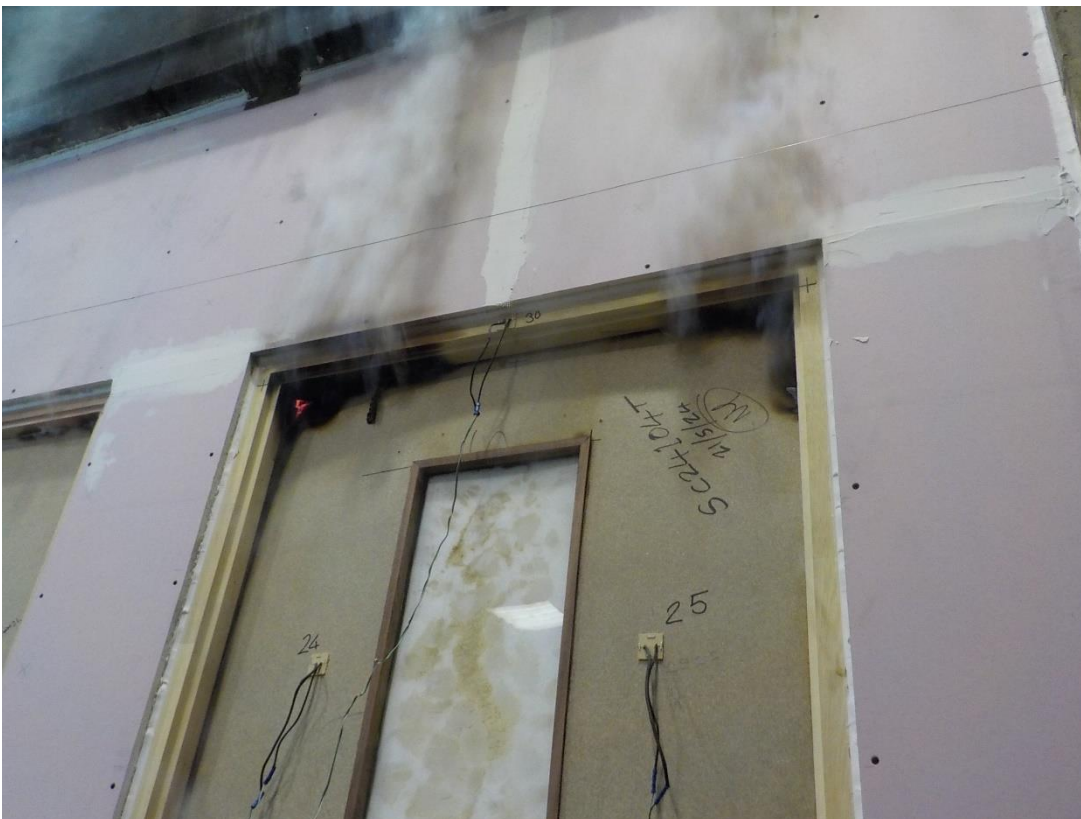
Photo 2.2.4 Right hand specimen after 39 minutes

34:12	U	Glowing is apparent at the closing stile/head corner.
36:17	U	A cotton pad is applied at the closing stile/head corner. No failure.
38:42	U	A cotton pad is applied at the closing stile/head corner. No failure.
