TEST REPORT NUMBER CFR2405291

FIRE RESISTANCE TEST IN ACCORDANCE WITH BS 476: PART 22: 1987

Sponsor:	Dixon International Group Ltd	Wood International Agency Limited
Address:	Brewery Road, Pampisford, Cambridgeshire, CB22 3HG	Wood House, 16 King Edward Road, Brentwood, Essex, CM14 4HL
Date of test:	29 th May 2024

Two latched single acting single leaf timber doorsets with an aperture for glazing, each tested opening towards the heating conditions of test with the left hand doorset tested as insulated and the right hand doorset tested as partially insulated.

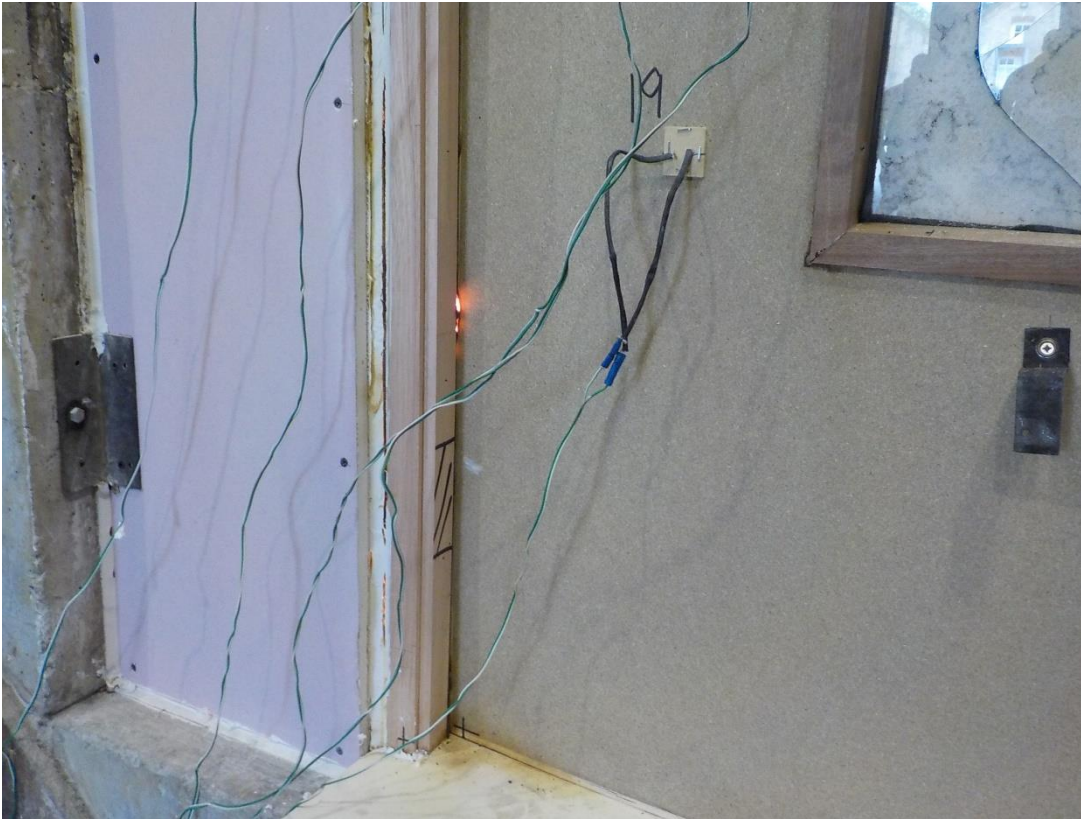
Photo 2.2.7 Left hand specimen after 64 minutes

61:15	U	Glowing is apparent at the hanging stile/head corner.
62:46	U	Flash flaming occurs at the hanging stile, nominally 300 above the base.
63:29	U	A cotton pad is applied at the hanging stile, nominally 300 above the base. No failure.

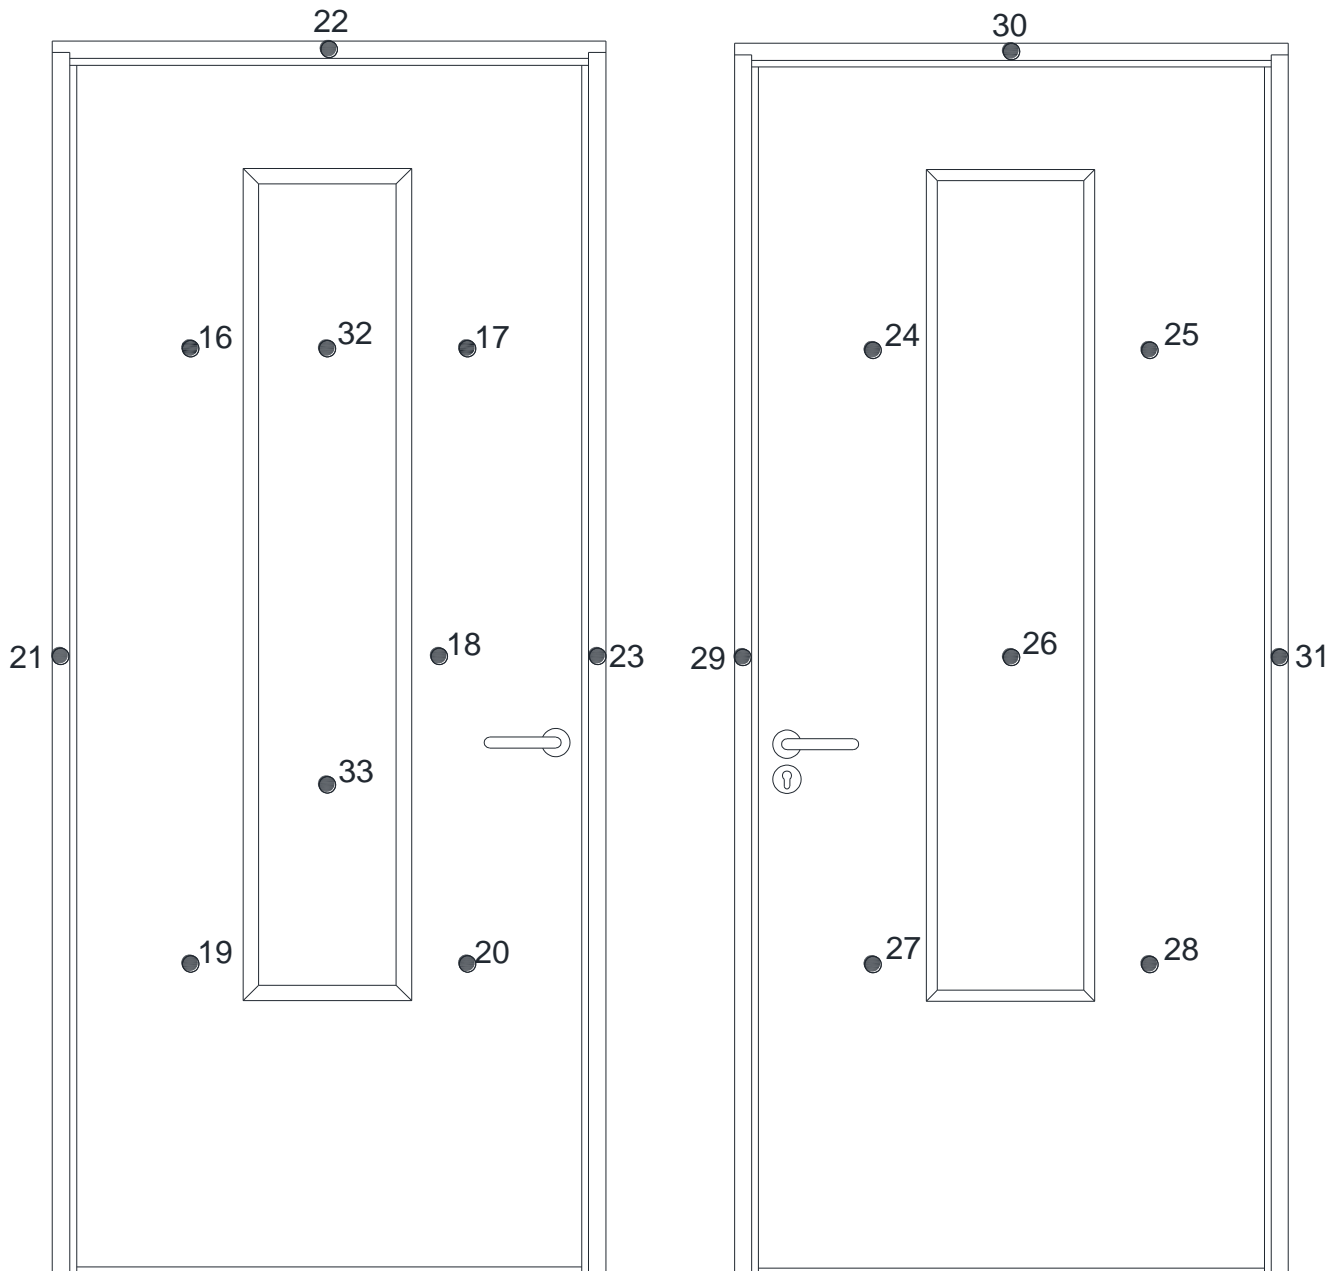
APPENDIX 3 POSITIONING OF INSTRUMENTATION

● Unexposed face specimen thermocouple

The positions of these thermocouples are shown in Appendix 3.
