# Fire resistance test report

Test standard: BS EN 1634-1:2014 + A1:2018

Product: Two Asymmetrical, Single-Acting, Single-Leaf Timber Doorsets incorporating glazing

Report number: 557882/R

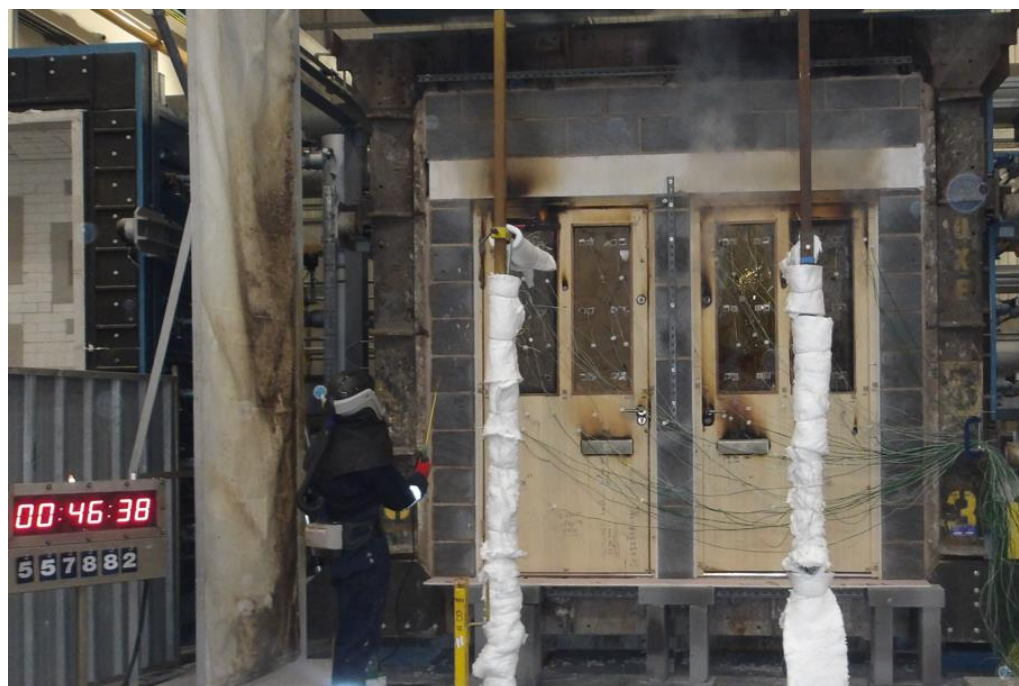
The unexposed face of the doorsets after a test duration of 46 minutes showing sustained flaming on Doorset A

| <b>46</b> | <b>00</b> | <b>Cotton pad applied to the bottom of the door closer on Doorset A and ignited. Cotton pad integrity failure is deemed to have occurred.</b> |
| <b>46</b> | <b>10</b> | <b>Sustained flaming on the door closer of Doorset A. Sustained flaming integrity failure is deemed to have occurred.</b> |
| <b>46</b> | <b>38</b> | <b>Flaming on the door closer of Doorset A has been extinguished with water. All modes of integrity failure are no longer deemed to be satisfied.</b> |

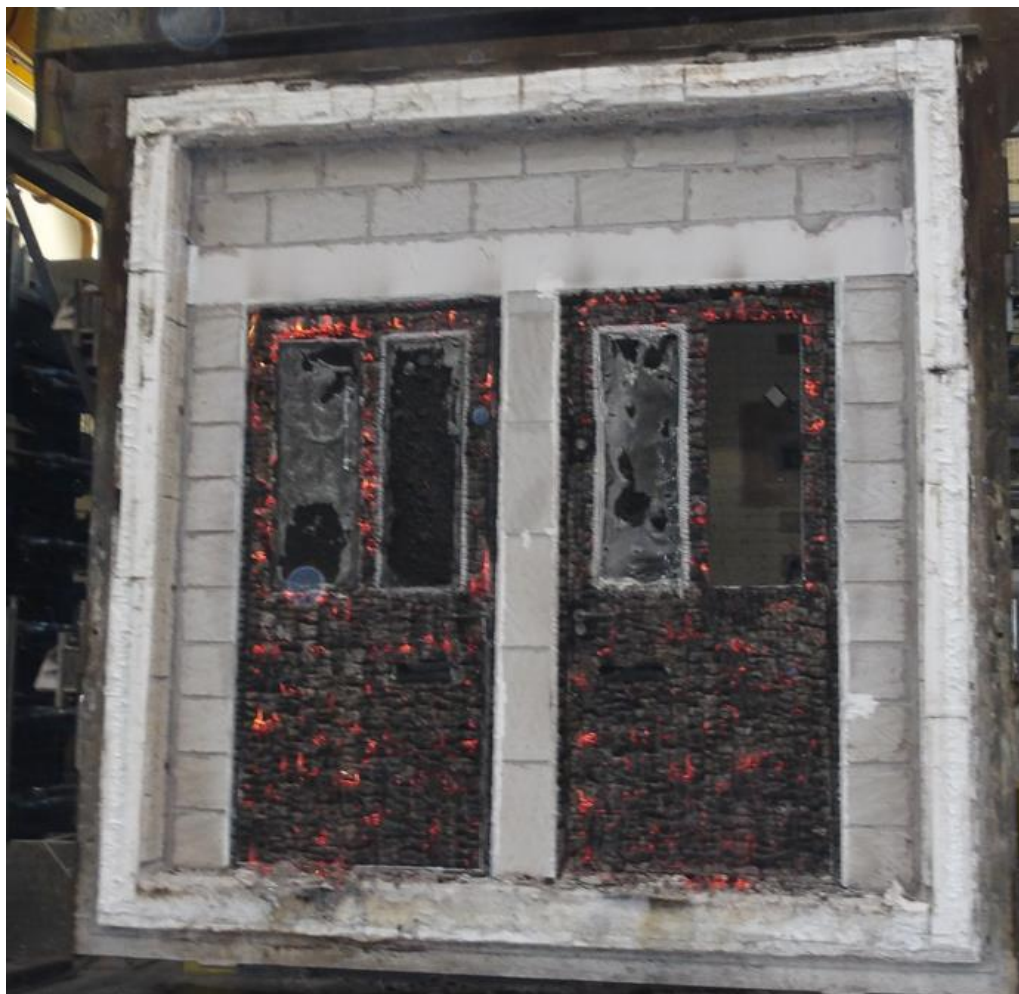
The exposed face  
of the doorsets  
immediately after  
the test
